Figure 2
Cooling Water Recharge Pond
Facing Northwest
Site Qualitative Ecological Assessment
Nuclear Metals, Inc. Site
Concord, Massachusetts

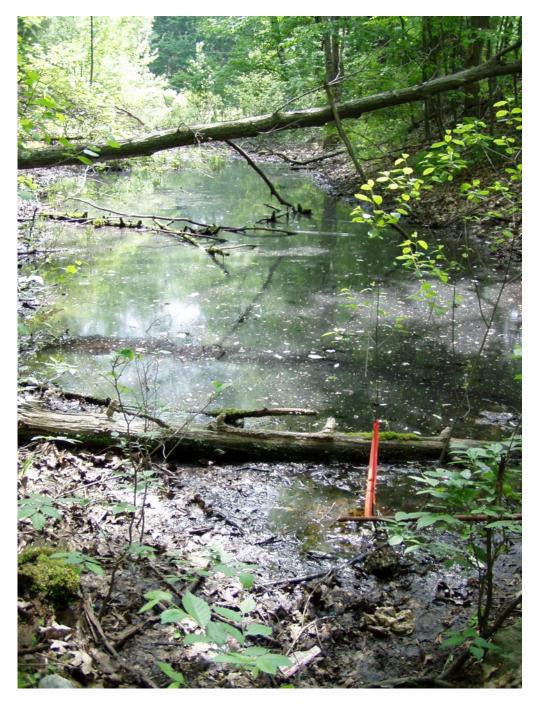
Northeast Wetland.

Figure 3 Northeast Wetland - Northeastern Portion Facing Southwest Site Qualitative Ecological Assessment Nuclear Metals, Inc. Site Concord, Massachusetts

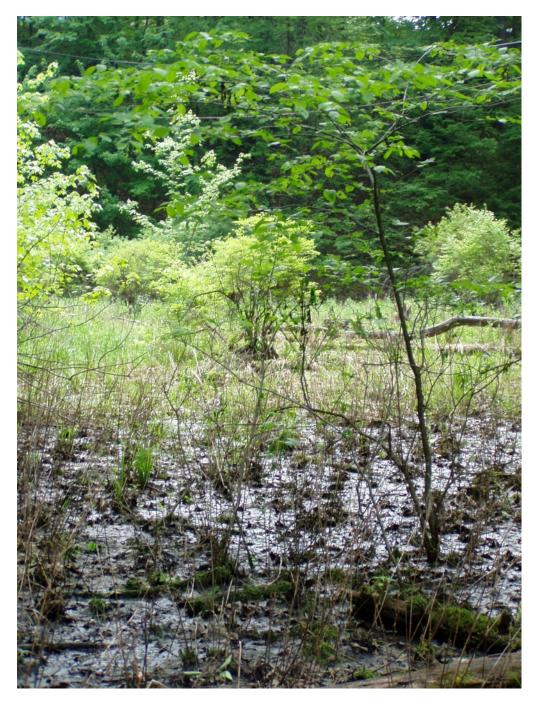
Northeast Wetland.

Figure 4
Northeast Wetland - Southwestern Portion
Facing Southwest
Site Qualitative Ecological Assessment
Nuclear Metals, Inc. Site
Concord, Massachusetts

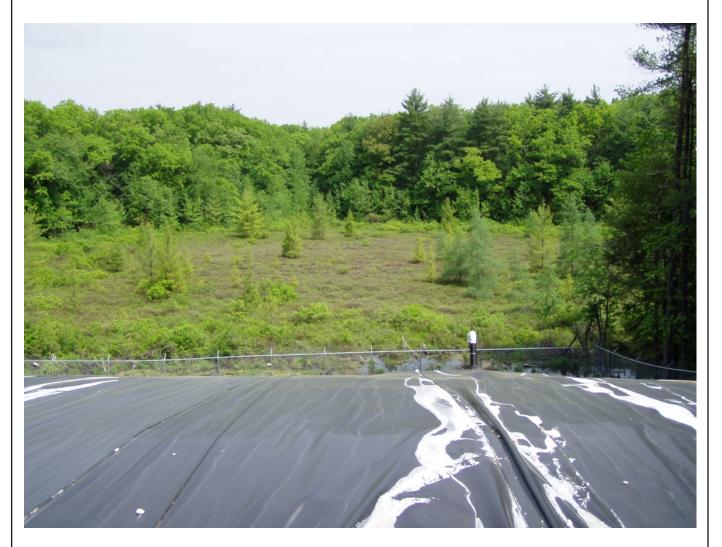
Figure 5 Sphagnum Bog Facing North Site Qualitative Ecological Assessment Nuclear Metals, Inc. Site Concord, Massachusetts

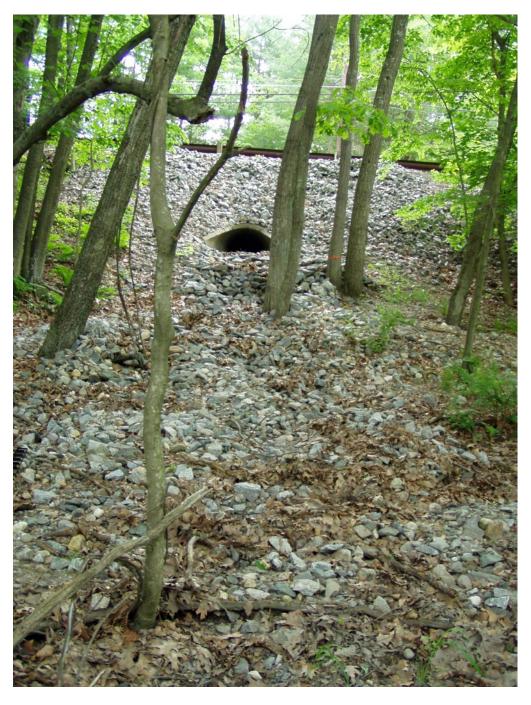
Pavement Drain Outfall North of Main Street.

Figure 6
Pavement Drain Outfall North of Main Street
Facing South
Site Qualitative Ecological Assessment
Nuclear Metals, Inc. Site
Concord, Massachusetts

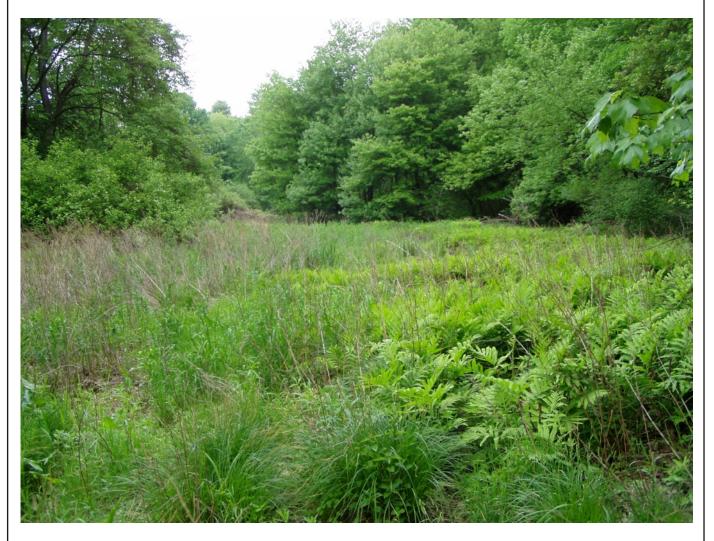
Wetland South of the Assabet River.

Figure 7
Wetland South of the Assabet River
Facing East
Site Qualitative Ecological Assessment
Nuclear Metals, Inc. Site
Concord, Massachusetts

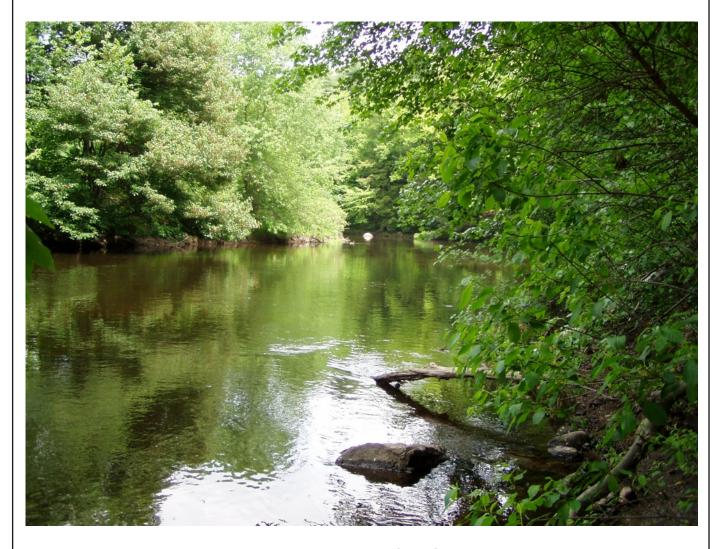
Assabet River North of the Site.

Figure 8
Assabet River North of the Site
Facing Northeast
Site Qualitative Ecological Assessment
Nuclear Metals, Inc. Site
Concord, Massachusetts

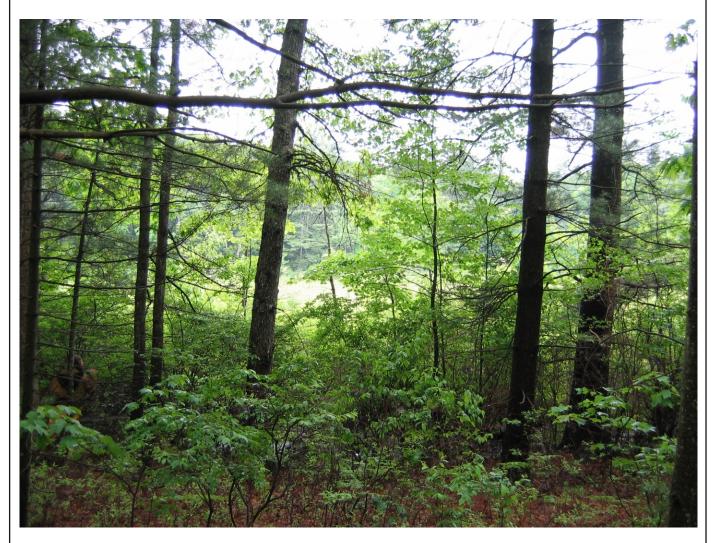
Westford Bog

Figure 10
Westford Bog, Westford
Candidate Reference for the Sphagnum Bog
Facing West
Site Qualitative Ecological Assessment
Nuclear Metals, Inc. Site
Concord, Massachusetts
